Bustins Island Green Infrastructure Project Final Presentation

*A Maine Coastal Community Grant
September 2019 – December 2021*

November, 2021

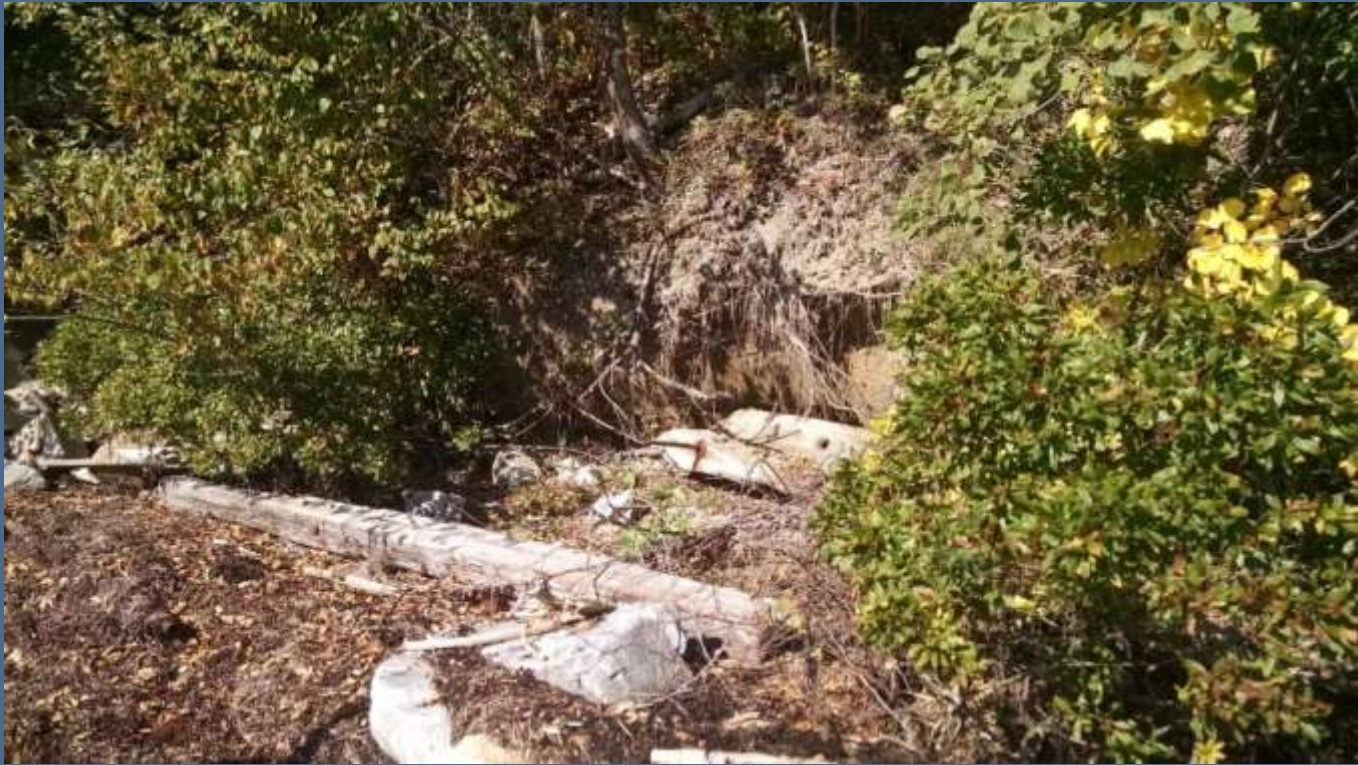
Bluff failure at location of arrow

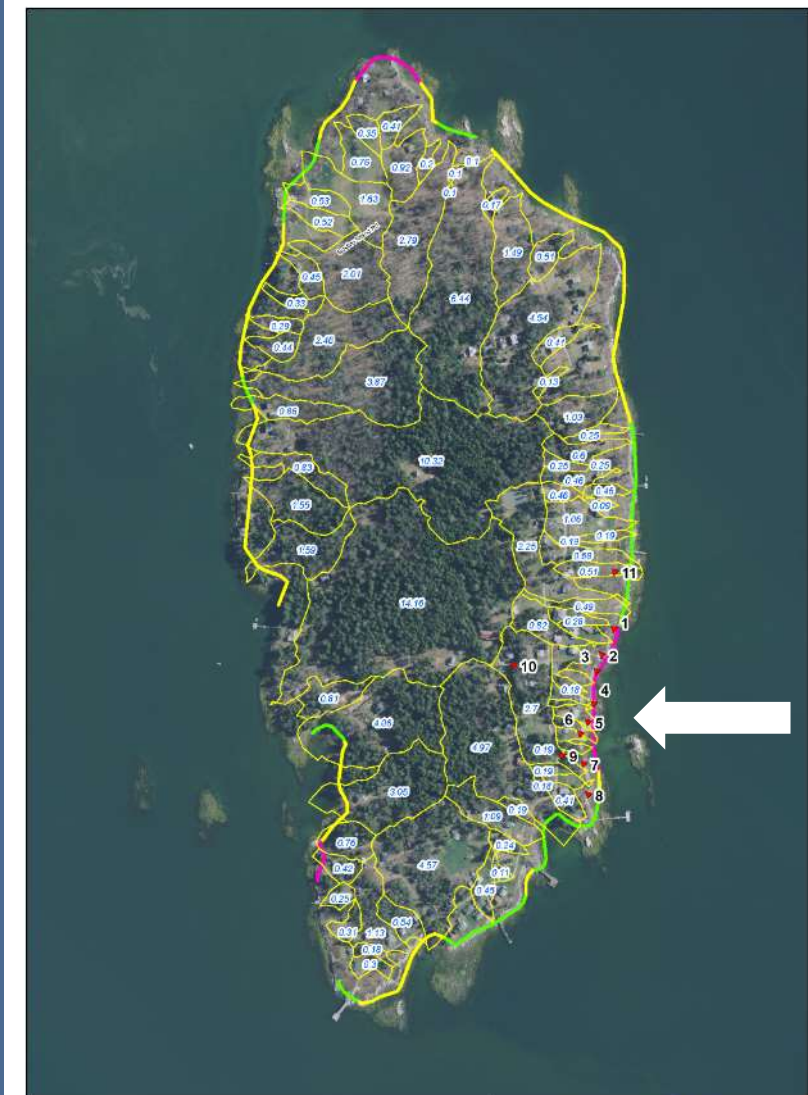
Figure A2: Bustins Island Overview See Appendix A for description

- ▲ Bustins Skew
- Sub-Watershed (Arrows)
- Stable
- Unstable
- Highly Unstable
- Local Road

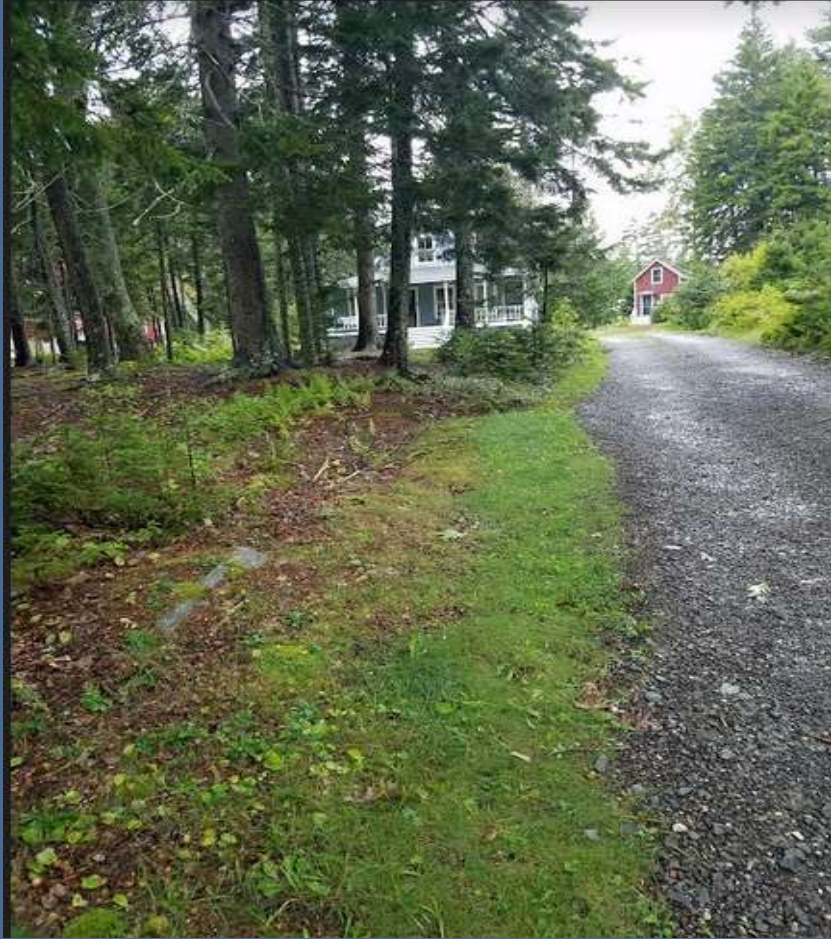
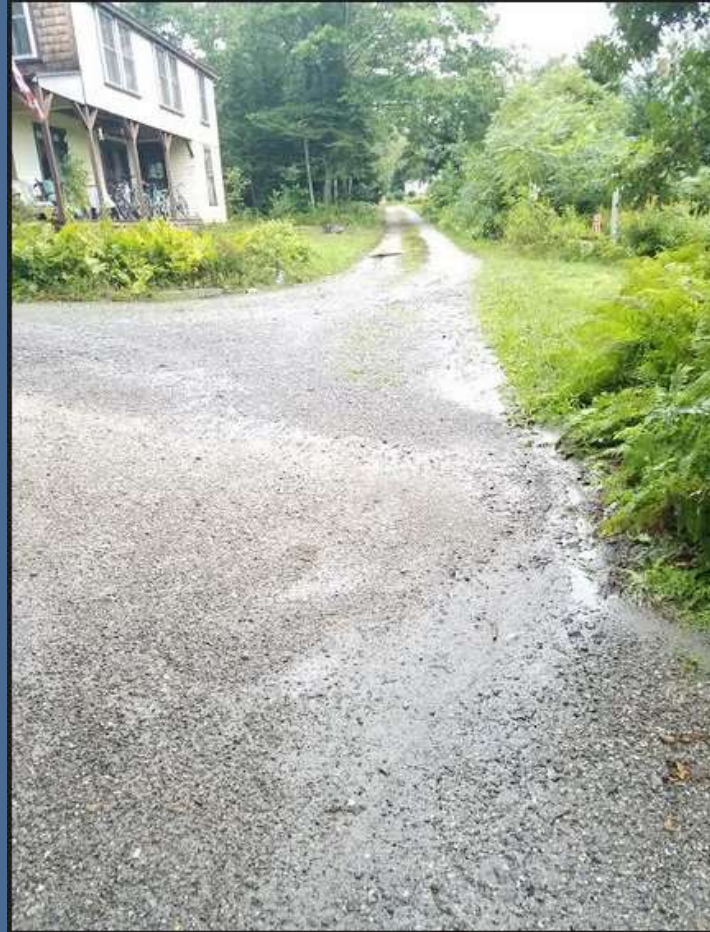
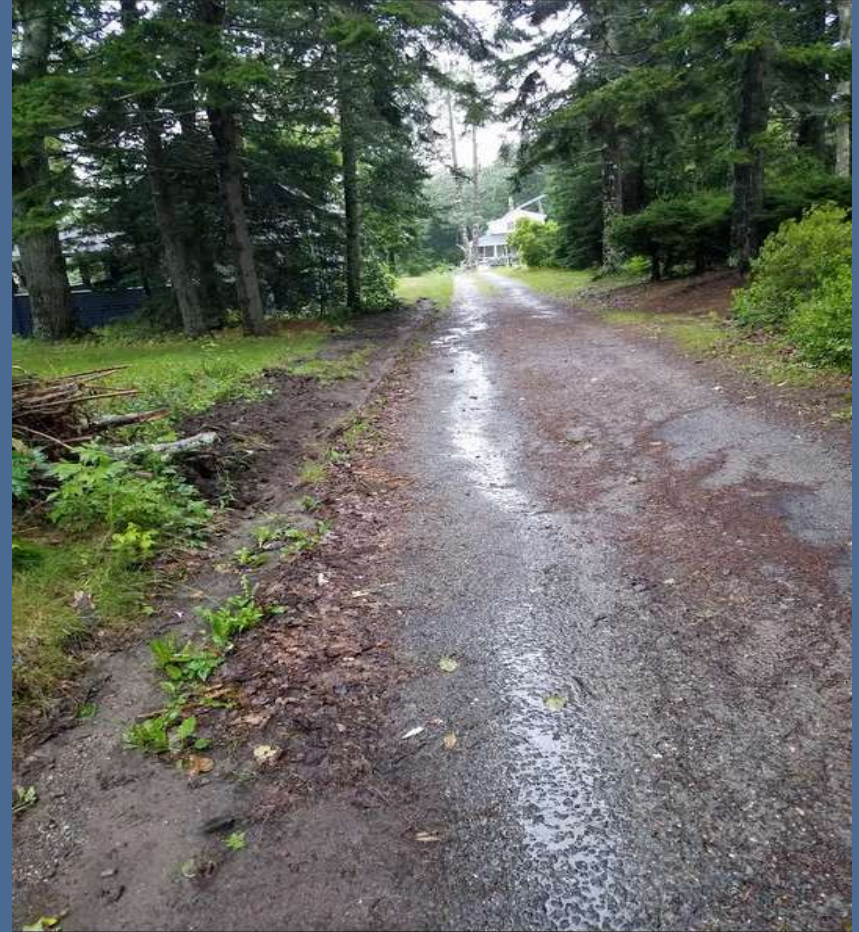
Runoff from roads A & B merges at intersection near Rowe's, runs toward and over sloping hill, gaining momentum

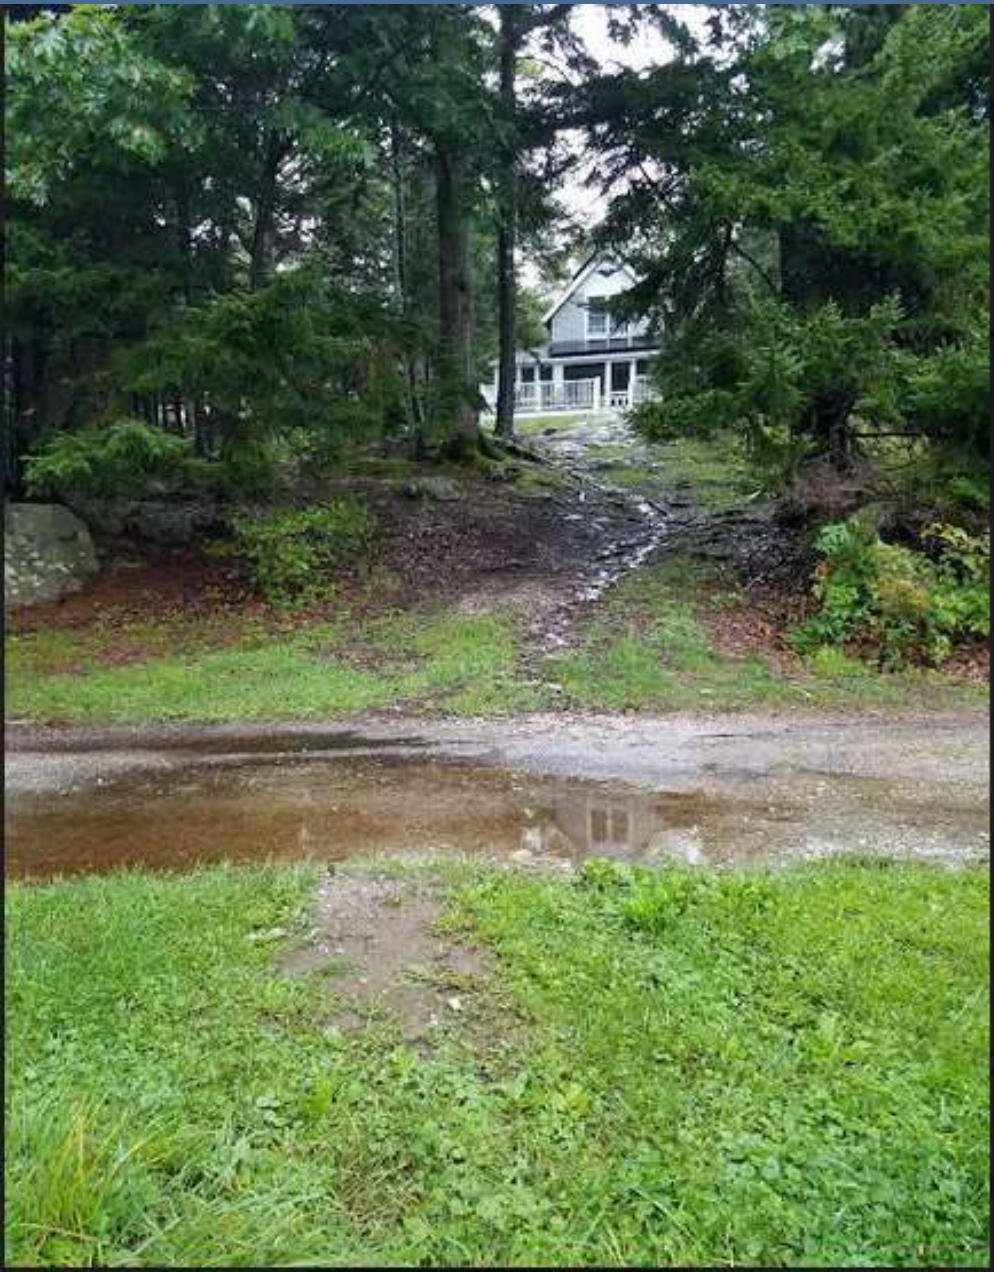
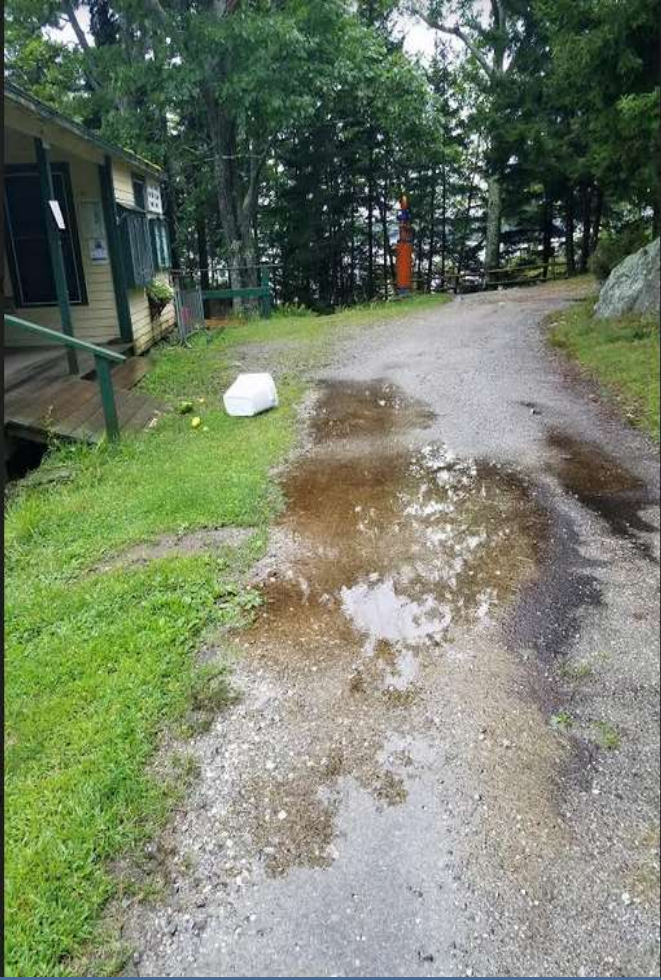
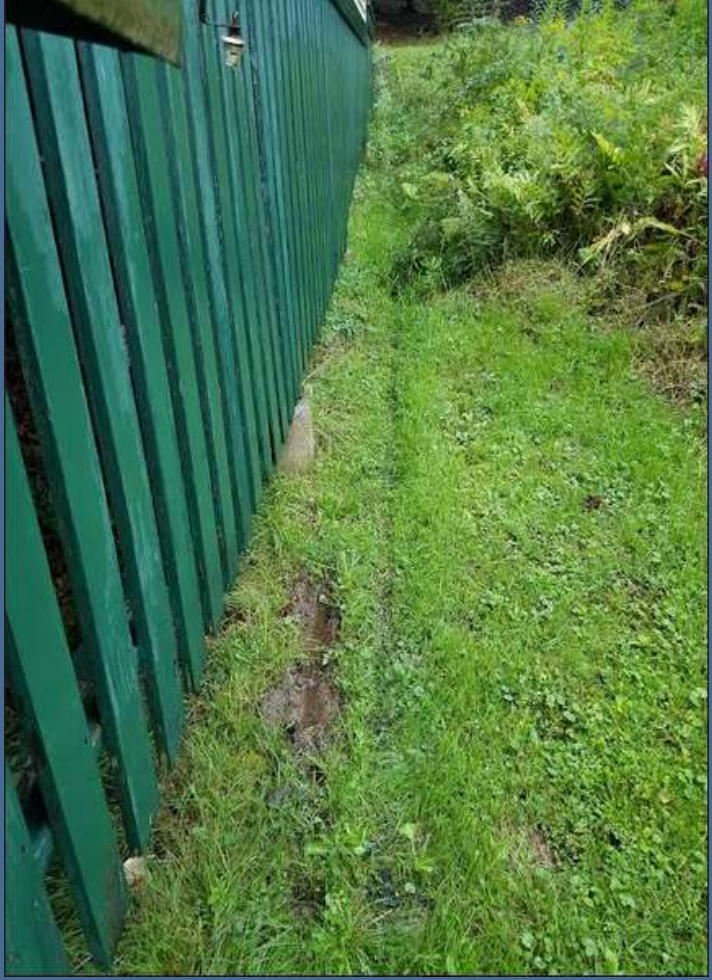
Runoff from the hill crosses the road in front of Store Porch, runs down slope past side of library....

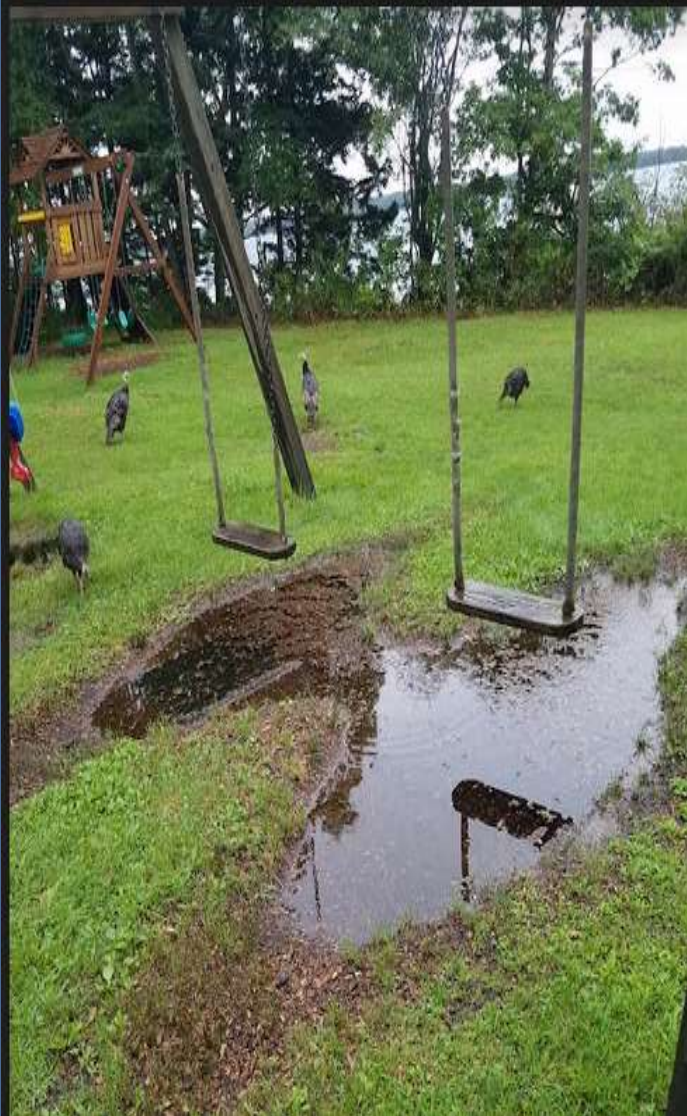
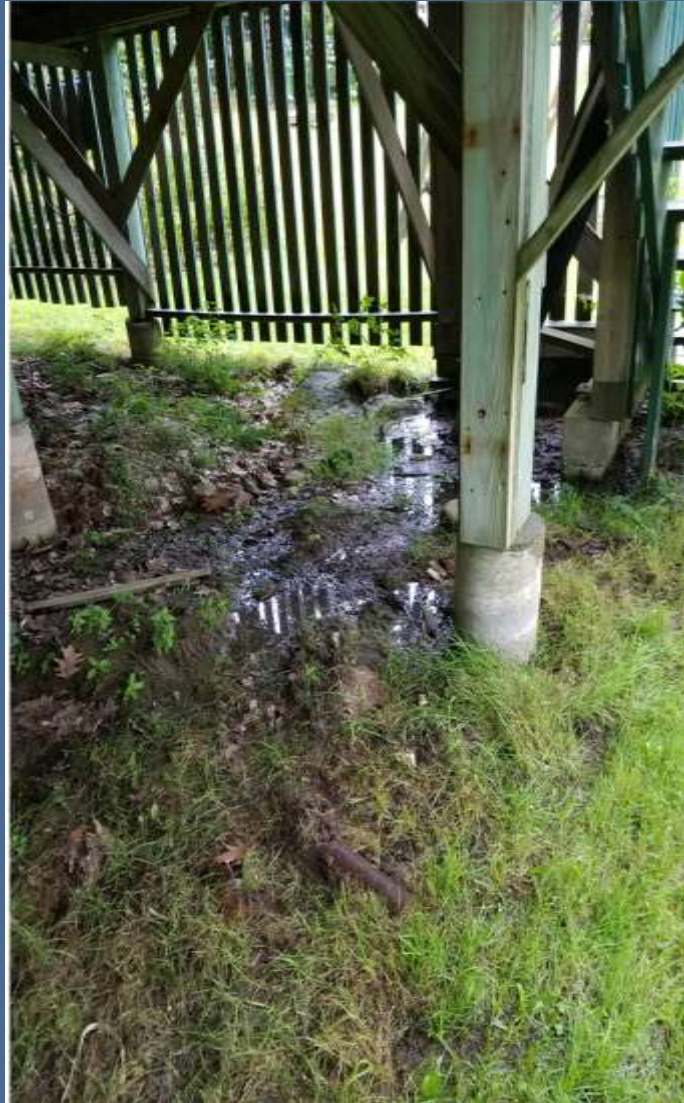
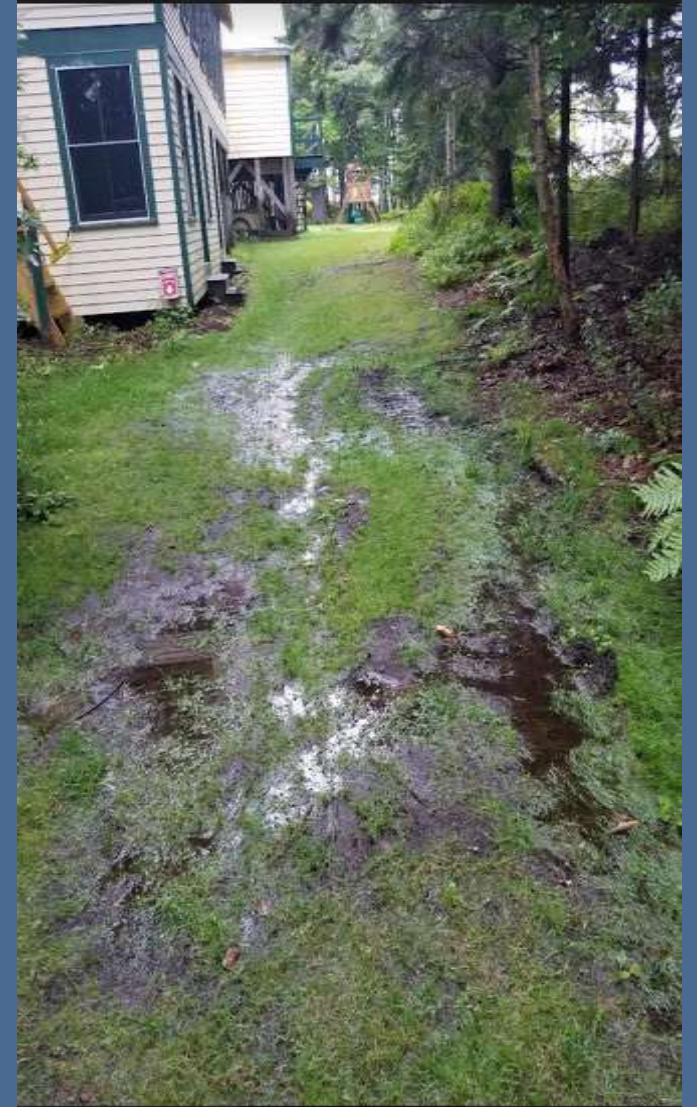
Runoff accumulates at lowest points: under swings, under and in back of buildings

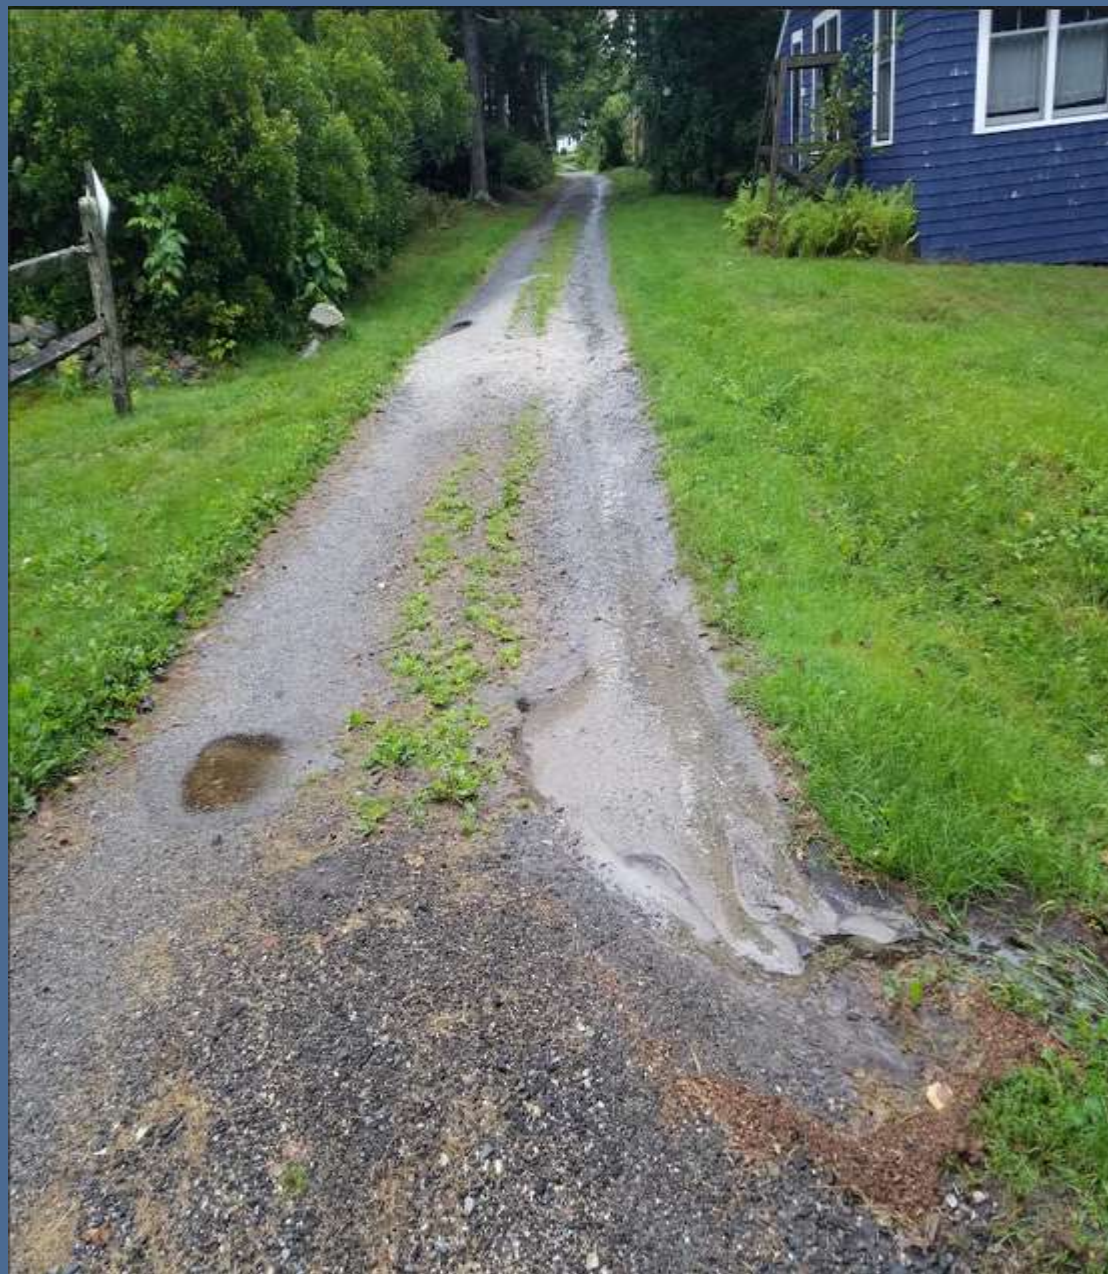
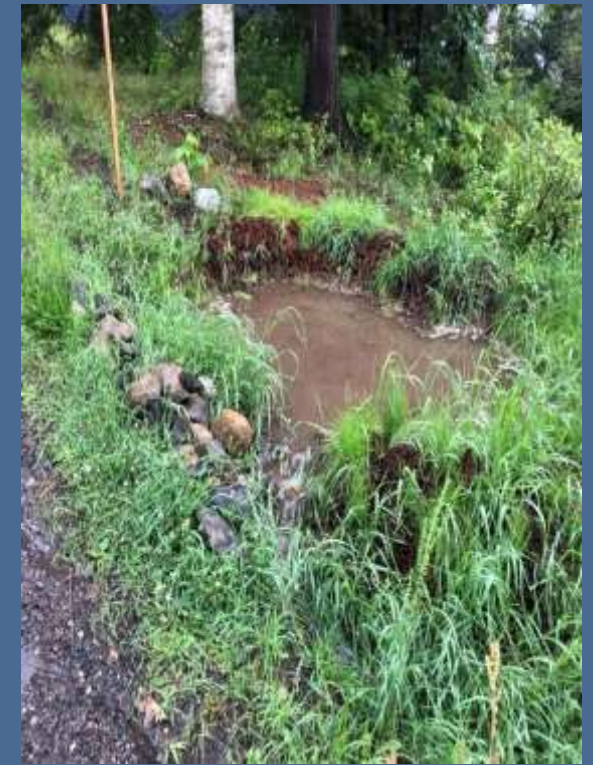
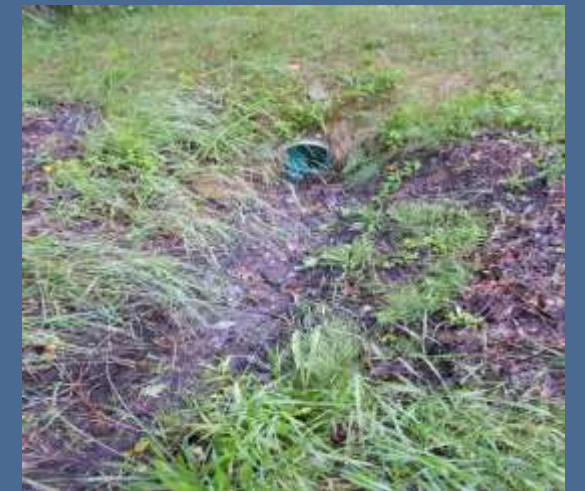
**WORK
TO DATE:**
Runoff is
diverted by a
berm in the
road
to a
roadside basin,
overflows
into
a ditch and
culvert
into...

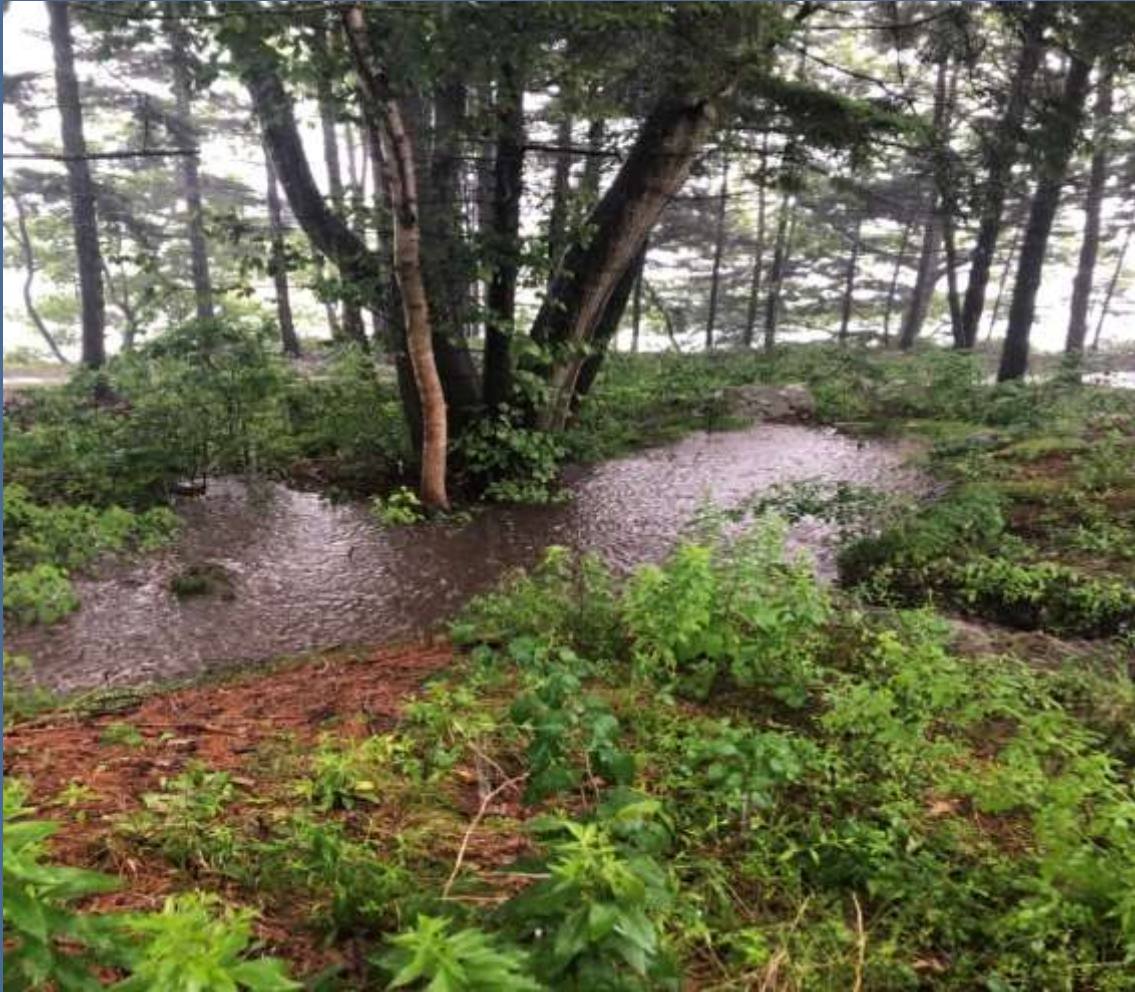
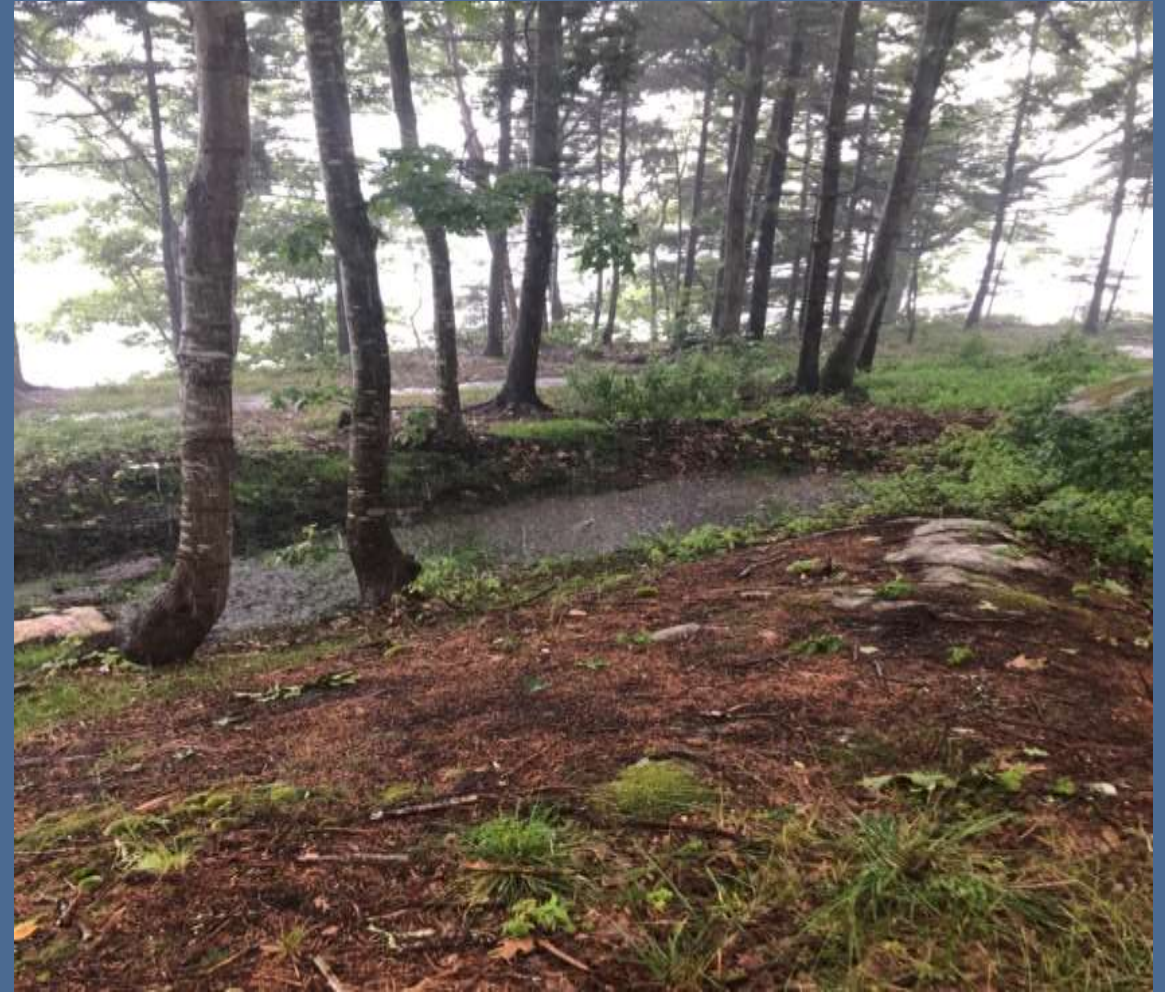
Natural basins capture stormwater runoff before it reaches the playground and unstable bluffs

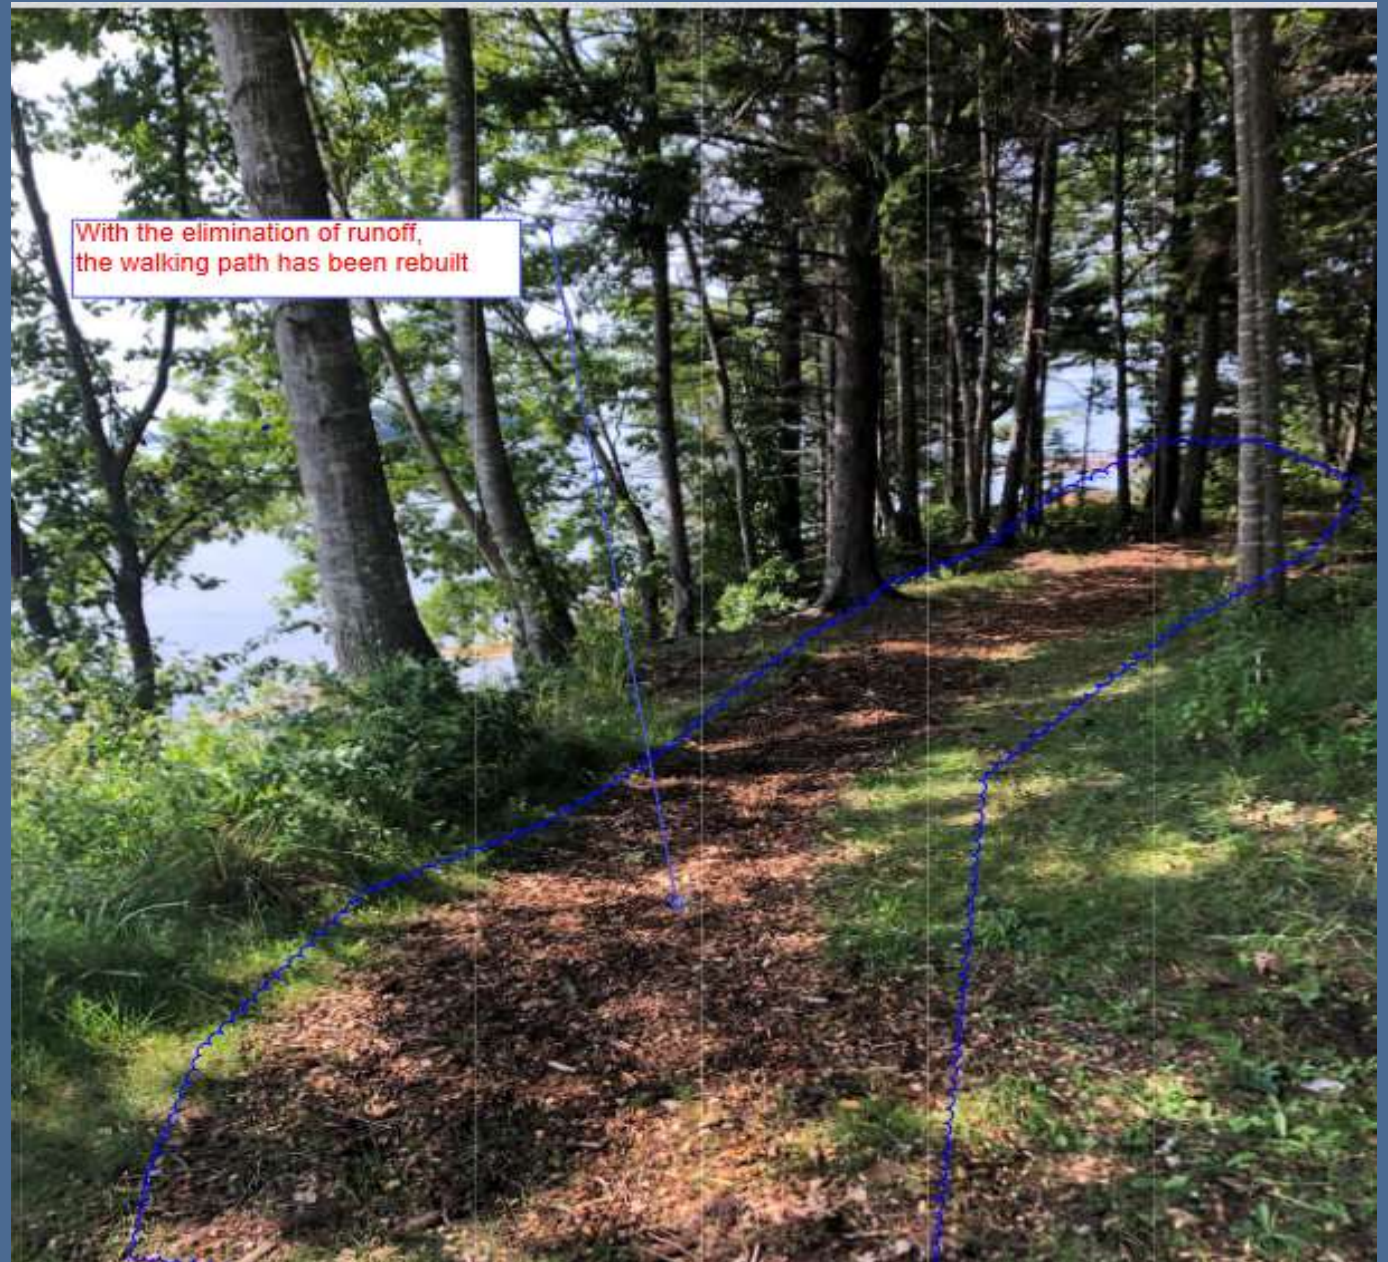
With the elimination of runoff, the walking path has been rebuilt

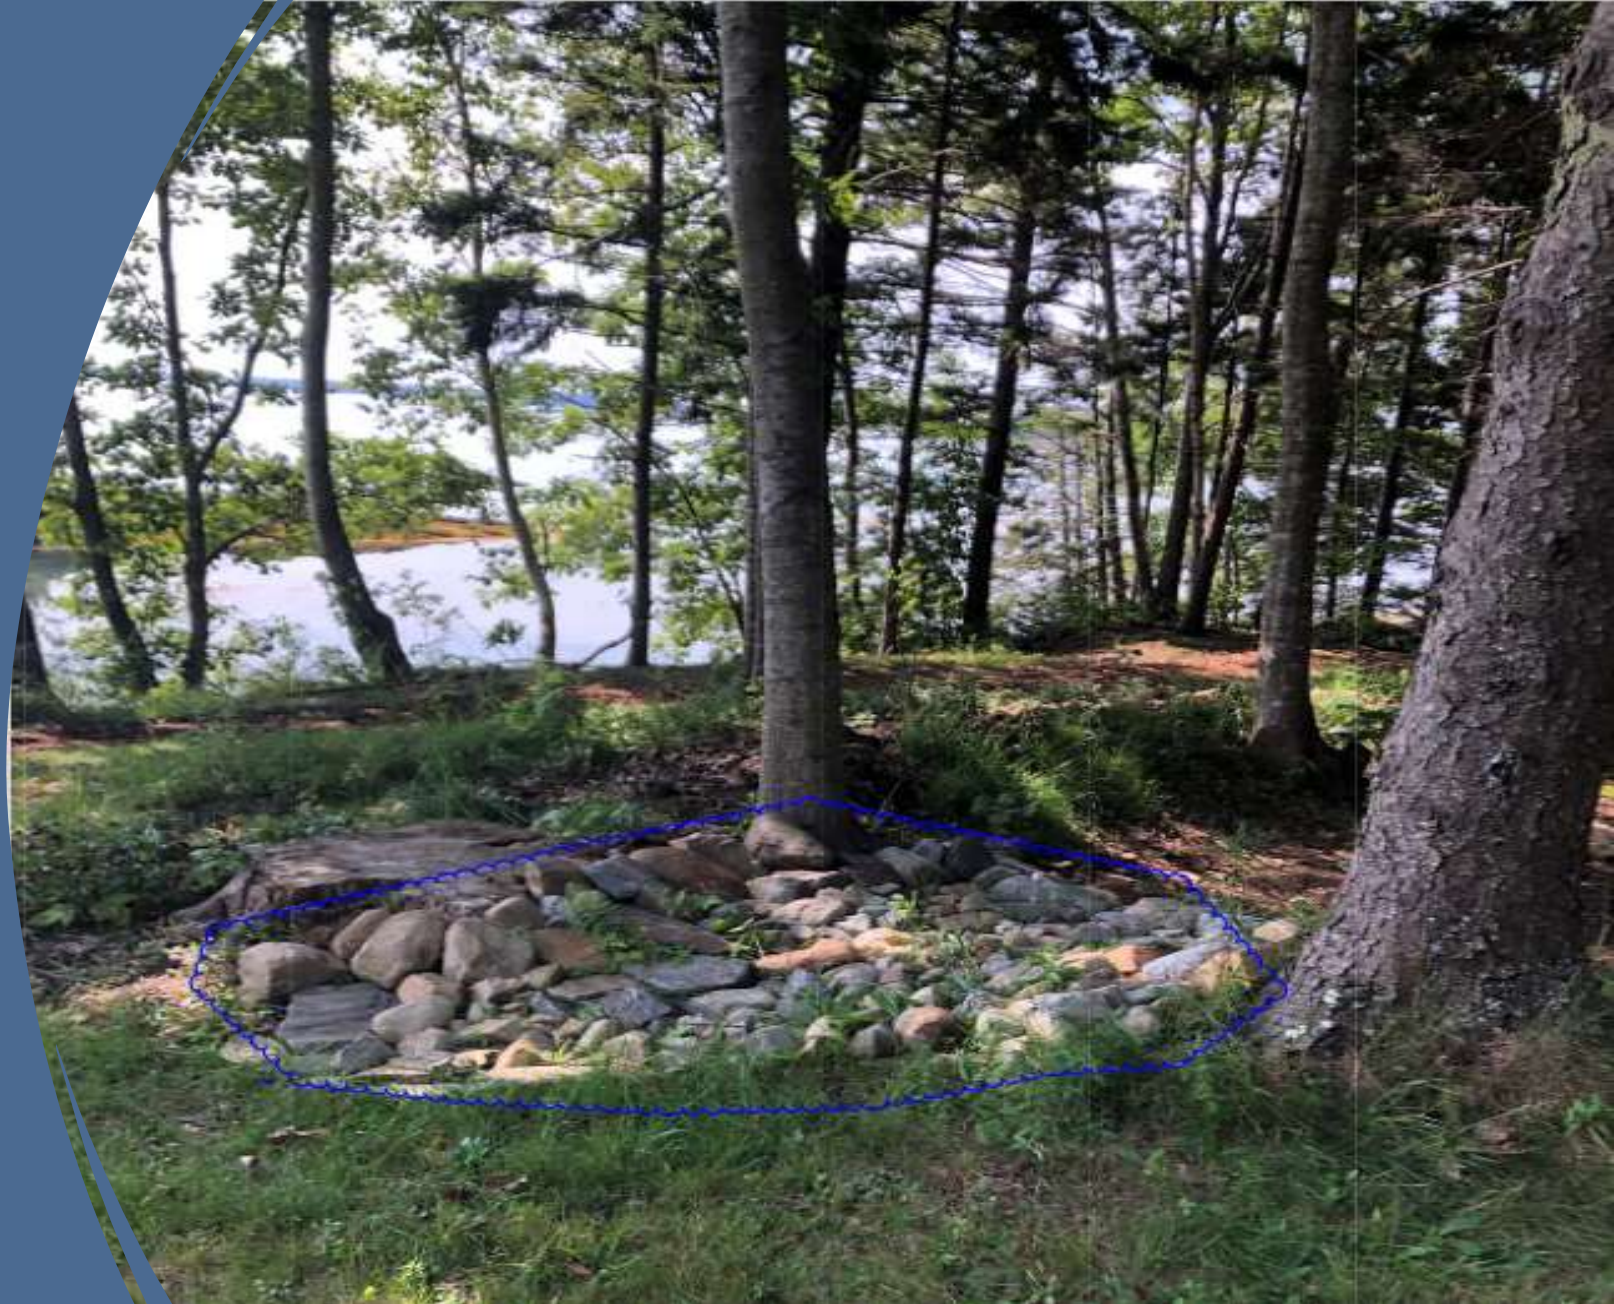
A reinforced outlet now directs runoff to a stable part of the bluff in a major rainstorm

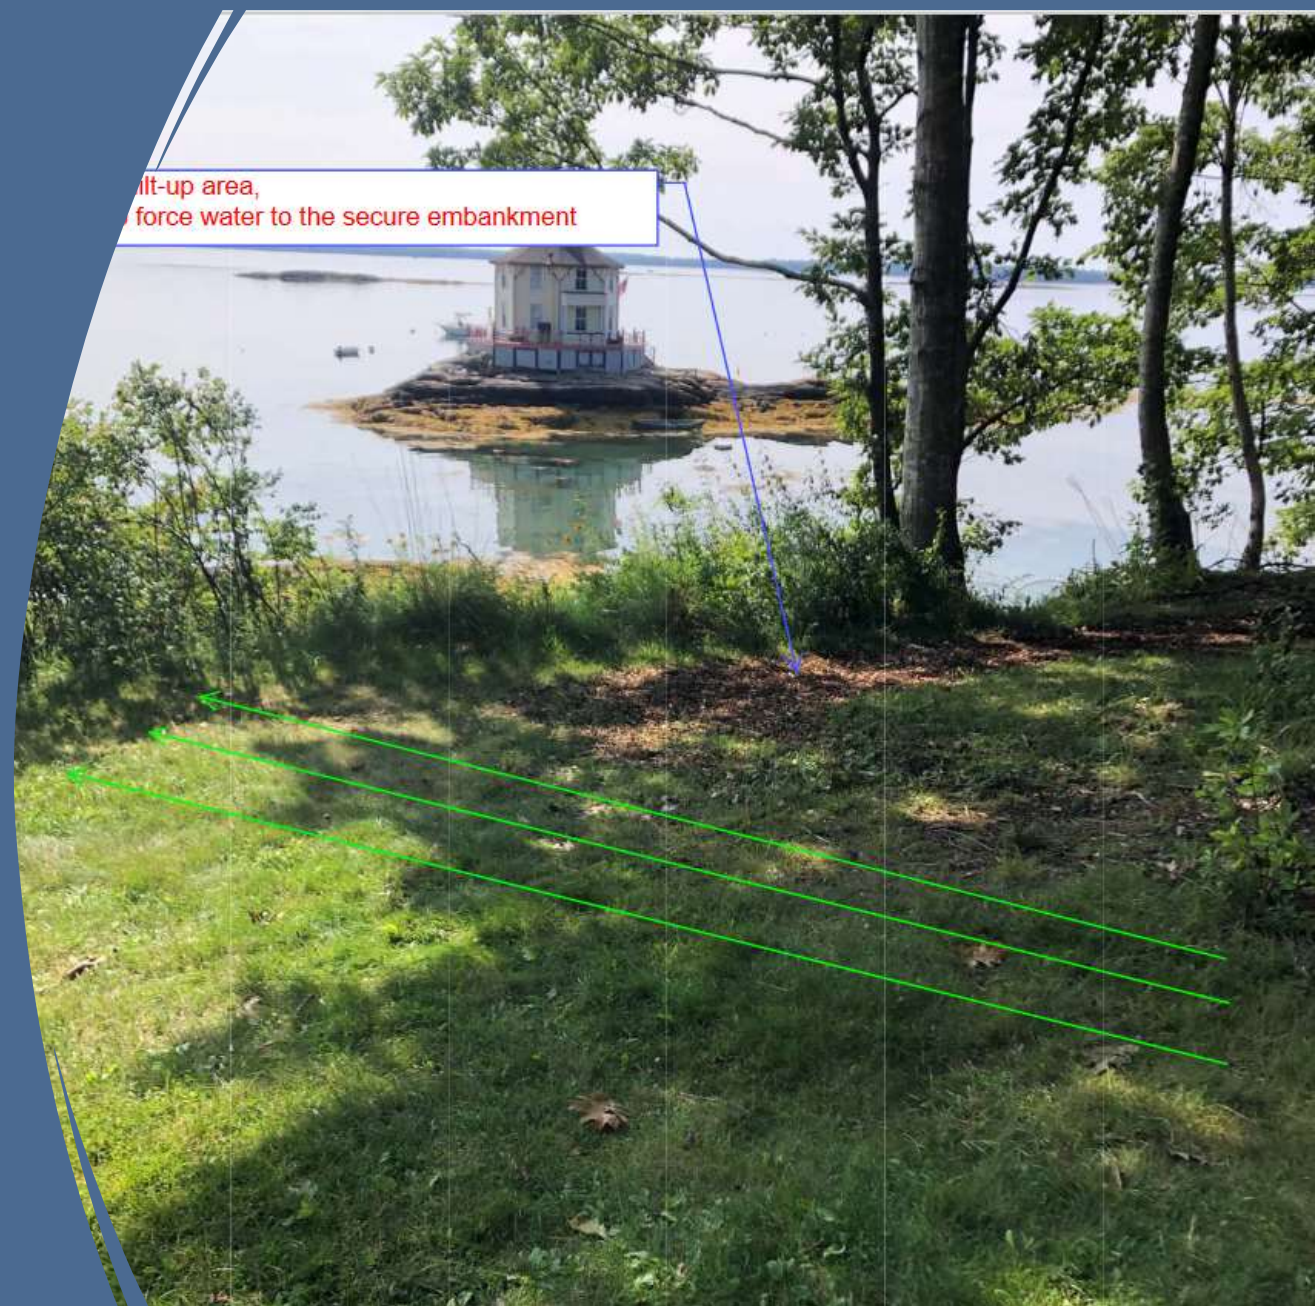
An earthen diversion berm will force overflow runoff to a secure part of the embankment in a major rainstorm

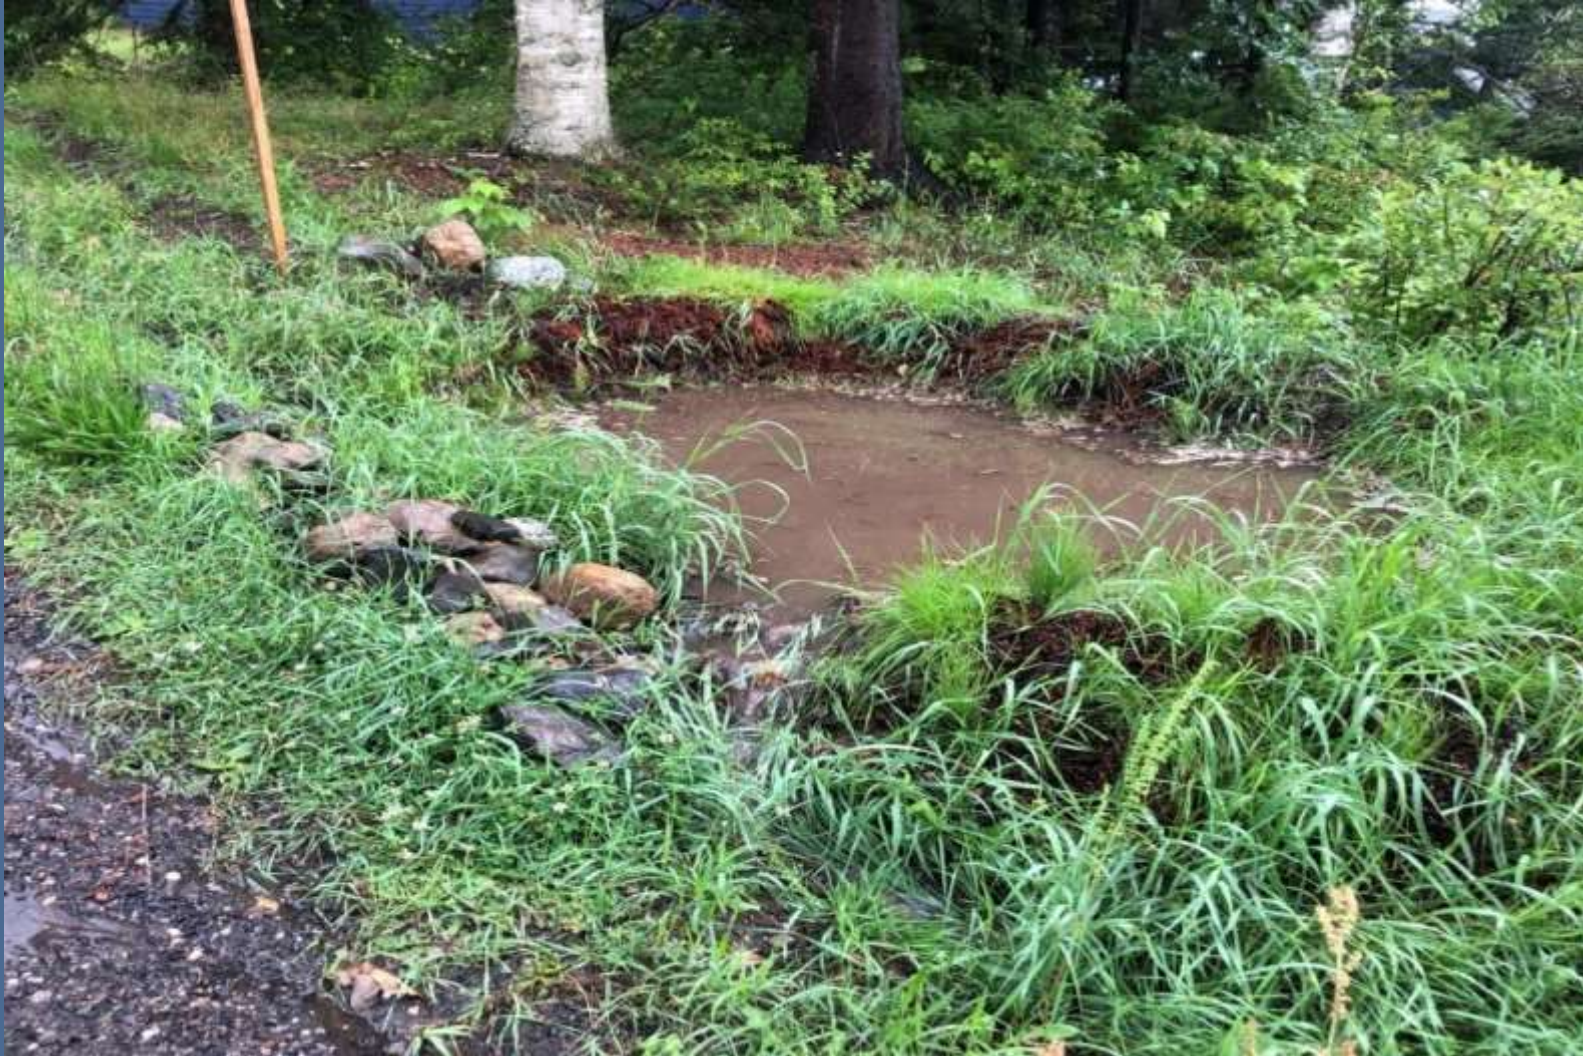
Pilot Project: Constructed roadside basin at top of road which now flows into ditch

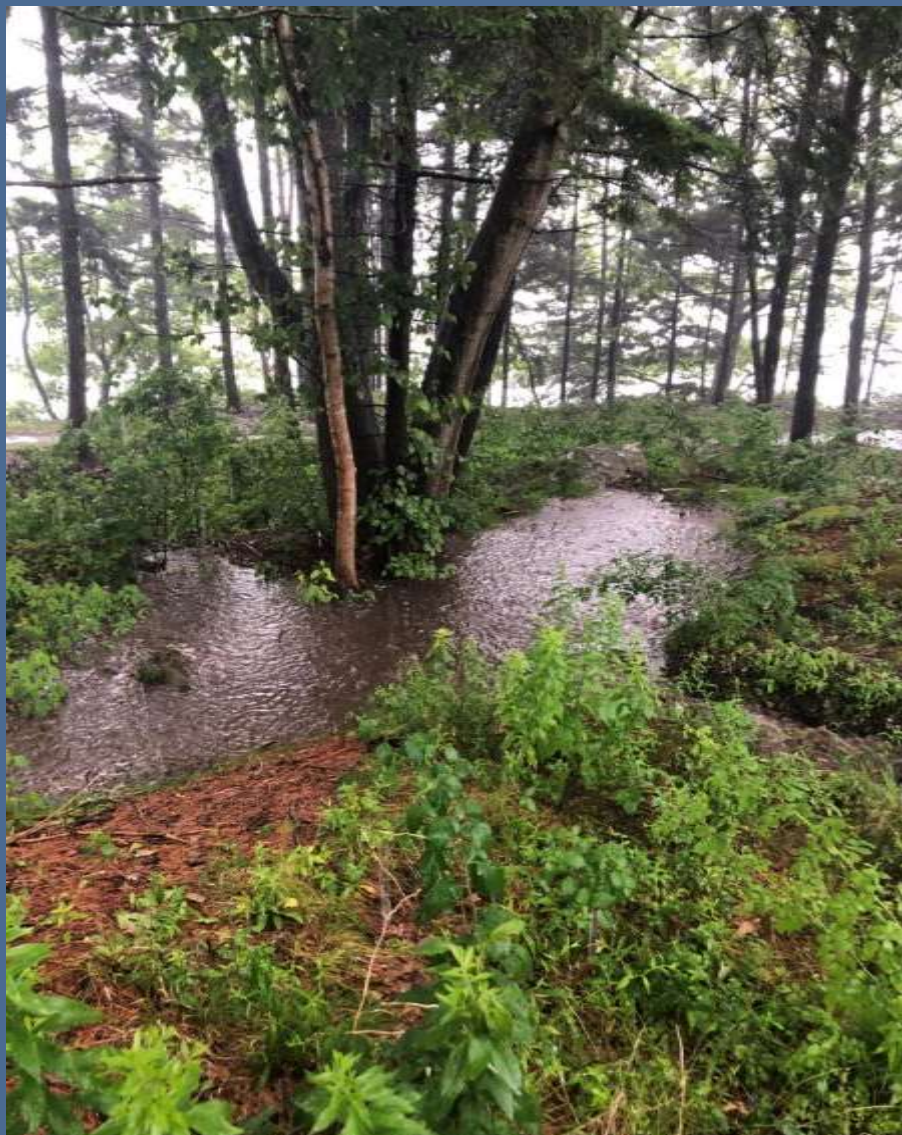
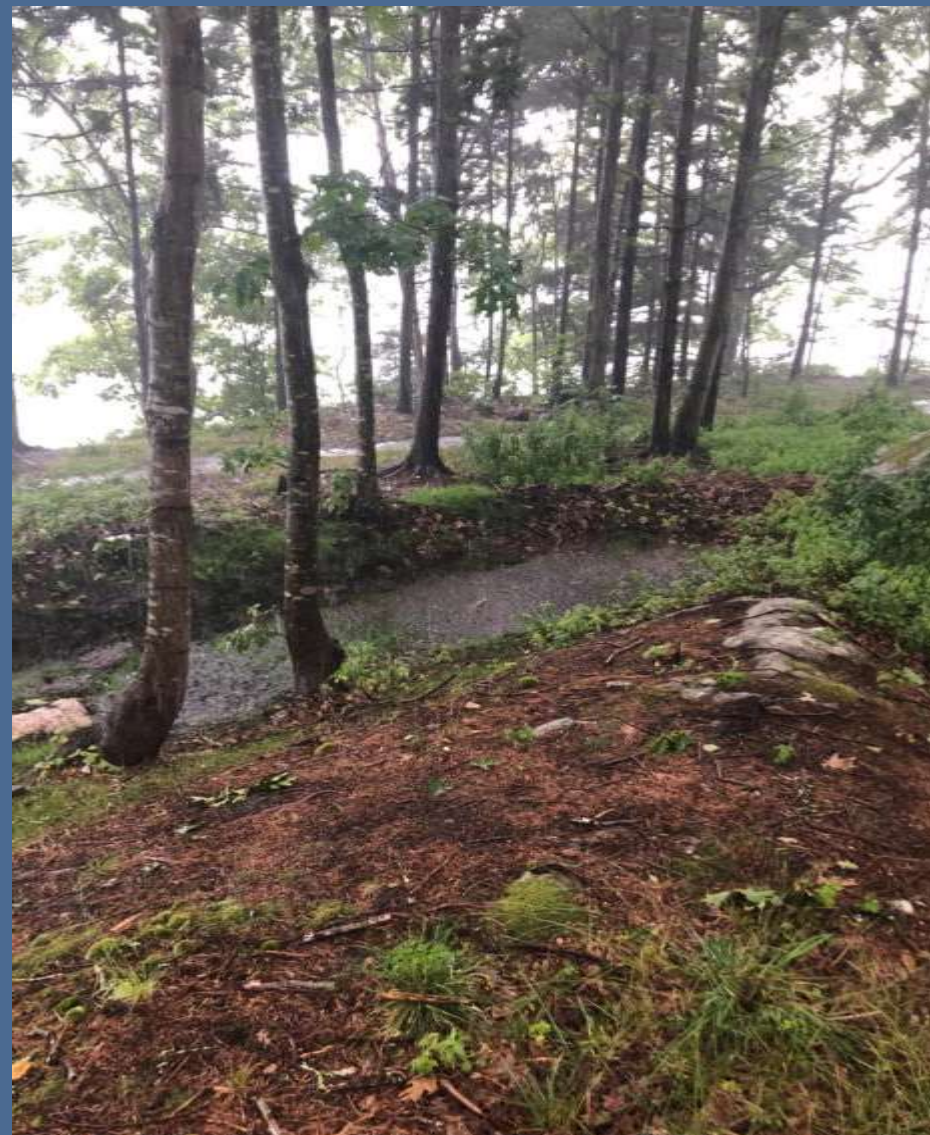
Pilot Project: Natural Settling Basins at System Outlet
